**Flood Control Project Maintenance
Levee Inspections**

Maintenance Issue Types Only, Levee Inspection Report By Mile - Fall 2018

Reclamation District No. 2104 Peters Pocket Tract

Waterway	Bank	Unit Miles	Inspection Start/End	Inspector
Unit No. 01 Cache Slough/Unit No. 02 Haas Slough	Left	6.85	11/01/2018 11/01/2018	David Julian

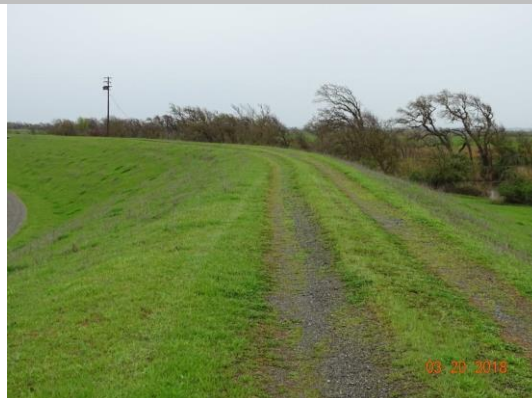
Photo 1 of 1 : FA_2018_RD2104_249_18_20180925_00007.jpg

LM Start	0.02	Rating **	A/W	Issue No.	18
LM End	1.45	Issue Type +	Ma	Location *	CR
Category	Earthen Levee			GPS Latitude/Longitude	
				Start	End
Item	Vegetation			38.308053 °	38.295298 °
				-121.758557 °	-121.741413 °
DWR ID	DWR_RD2104_01_f_2016_18				
Comment Code					
V9 : Keep the crown roadway free of vegetation.					
Inspector Comment

Spring 2018 - Crown road should be kept free of vegetation.

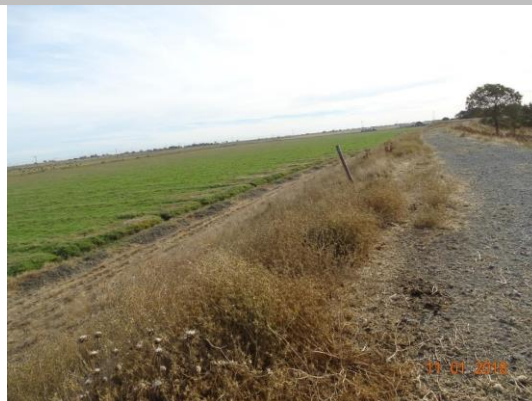
Photo 1 of 1 : FA_2018_RD2104_249_28_20181102_00035.jpg

LM Start	1.06	Rating **	M	Issue No.	28
LM End	1.32	Issue Type +	Ma	Location *	LS
Category	Earthen Levee			GPS Latitude/Longitude	
				Start	End
Item	Vegetation			38.297423 °	38.295770 °
				-121.747770 °	-121.743577 °
DWR ID	DWR_RD2104_01_f_2018_28				
Comment Code					
V1 : Control annual grass and weeds on the levee slopes and easements.					
Inspector Comment					
Maintain vegetation on land side slope

View looking downstream of vegetation on the land side slope (November 2018).

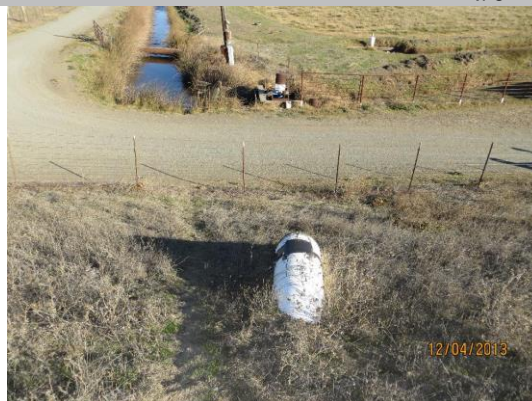
Photo 1 of 3 : UCIP_FA_2018_24984_45042.jpg

Comment Code					
Inspector Comment					
FS_ID:24984 DS_ID:24711 EP_NO: 10185 Repair Type: No Action Needed Crossing Status: Found UCIP Comments: 09/14/2017 Permit is unavailable, missing page 3 official permit documentation. (DWR UCIP - O. Magana) FIELD_STRUCT_DESC: 16-inch steel drainage pipe through the levee, 5.7 feet below the crown. Pump in an irrigation ditch on the landside (LS). Siphon breaker on the waterside (WS) slope. (Automatic Board Order (ABO) issued as Permit No. 10185, 1964 - Erwin E. and Lucy G. Vasser, limited details available electronic permit unavailable). [Additional Reference(s): DWR Levee Log, 2006. USACE Sacramento O&M Manual 108, April 1964, (HLM 1.52), Drawing Nos. 50-04-1977 and 50-04-3379]. FS Date: 12/4/2013

Pipe on LS slope with pump in irrigation ditch off LS toe visible in background.

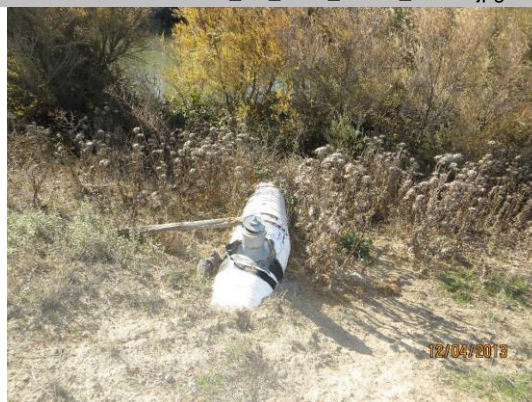
Photo 2 of 3 : UCIP_FA_2018_24984_45041.jpg

Siphon breaker on pipe at WS slope.

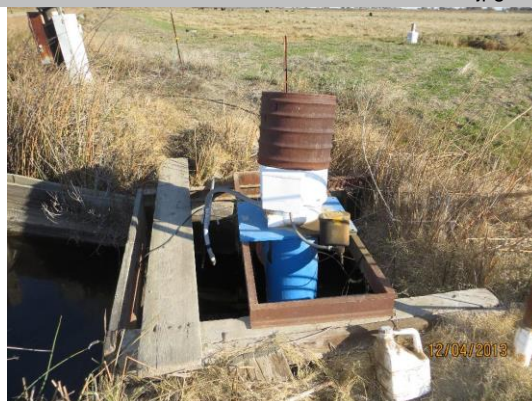
Photo 3 of 3 : UCIP_FA_2018_24984_45040.jpg

Pump in wooden distribution box off LS toe.

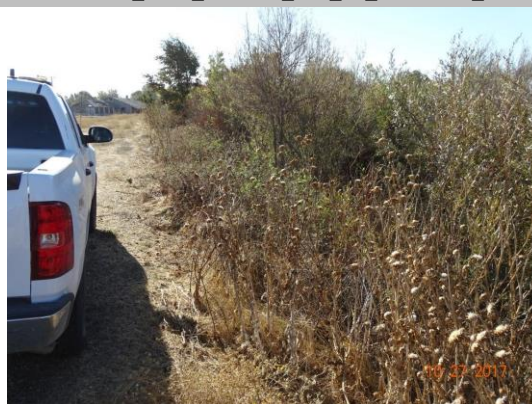
Photo 1 of 1 : FA_2018_RD2104_249_11_20180925_00002.jpg

LM Start	1.44	Rating **	U	Issue No.	11
LM End	1.48	Issue Type +	Ma	Location *	WS
Category	Earthen Levee			GPS Latitude/Longitude	
				Start	End
Item	Vegetation			38.295487°	38.294947°
				-121.741530°	-121.741215°
DWR ID	DWR_RD2104_01_f_2017_11				
Comment Code					
V2 : Remove the wild growth other than native grasses from the levee slopes.					
Inspector Comment

Remove wild growth to 20 feet from crown.

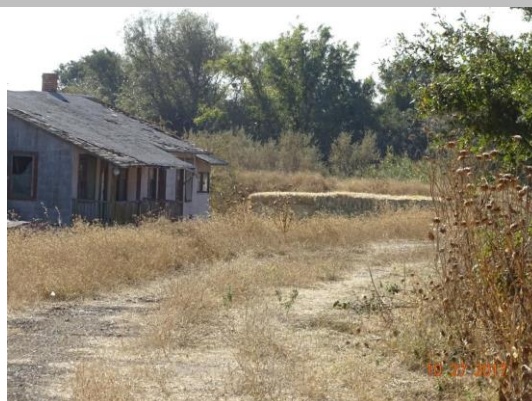
Photo 1 of 1 : FA_2018_RD2104_249_13_20180925_00003.jpg

LM Start	1.45	Rating **	A/W	Issue No.	13
LM End	4.72	Issue Type +	Ma	Location *	CR
Category	Earthen Levee			GPS Latitude/Longitude	
				Start	End
Item	Vegetation			38.295298 °	38.318398 °
				-121.741413 °	-121.744603 °
DWR ID	DWR_RD2104_01_f_2017_13				
Comment Code					
V9 : Keep the crown roadway free of vegetation.					
Inspector Comment

Crown vegetation should be reduced to facilitate inspection and access.

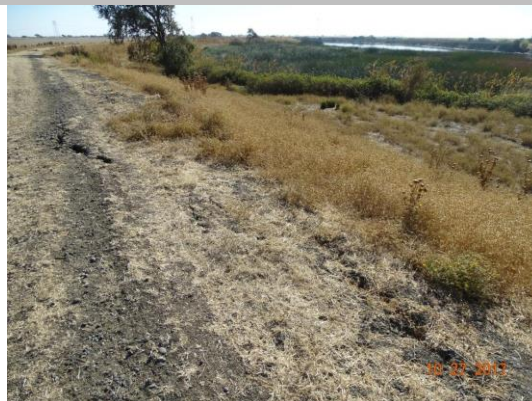
Photo 1 of 1 : FA_2018_RD2104_249_15_20180925_00004.jpg

LM Start	1.72	Rating **	A/W	Issue No.	15
LM End	1.72	Issue Type +	Ma	Location *	WS
Category	Earthen Levee			GPS Latitude/Longitude	
				Start	End
Item	Cracking			38.293465°	38.293465°
				-121.737778°	-121.737778°
DWR ID	DWR_RD2104_01_f_2017_15				
Comment Code					
CR1 : Monitor and have inspected by geotechnical engineer.					
Inspector Comment

Curved cracks in crown indicate possible slope instability on waterside slope. Cracks are 8 feet long x up to 6 inches wide x 3 feet deep. No other indications of slope instability observed. Levee toe is approx 40 feet from channel/slough edge.

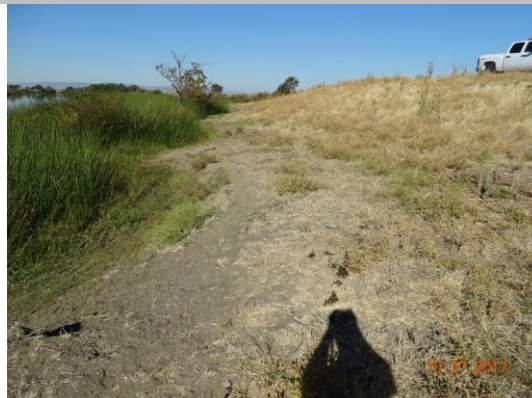
Photo 1 of 1 : FA_2018_RD2104_249_16_20180925_00005.jpg

LM Start	1.93	Rating **	M	Issue No.	16
LM End	1.94	Issue Type +	Ma	Location *	WS
Category	Earthen Levee			GPS Latitude/Longitude	
				Start	End
Item	Erosion / Bank Caving			38.292027°	38.291947°
				-121.734575°	-121.734453°
DWR ID	DWR_RD2104_01_s_2012_16				
Comment Code					
E1 : Note and monitor erosion site.					
Inspector Comment

Scalloped bank erosion along slough is approaching levee toe.

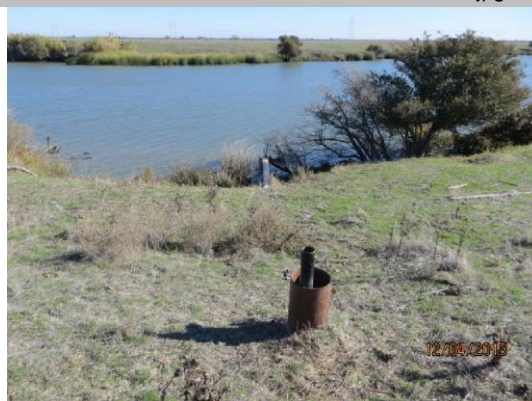
Photo 1 of 2 : UCIP_FA_2018_24990_45047.jpg

Comment Code						
Inspector Comment						
FS_ID:24990 DS_ID:24708 EP_NO: 10185 Repair Type: No Action Needed Crossing Status: Found UCIP Comments: 09/14/2017 Permit is unavailable, missing page 3 official permit documentation. (DWR UCIP - O. Magana) FIELD_STRUCT_DESC: 12-inch steel drainage pipe through the levee, 4 feet below the crown. Pump on pile structure in drainage canal on the landside (LS). Siphon breaker in a 12-inch steel riser on the waterside (WS) slope. (Automatic Board Order (ABO) issued as Permit No. 10185, 1964 - Erwin E. and Lucy G. Vasser, limited information available electronic version of permit missing. Replaced under Permit No. 4412, 1963 - Ervin E. and Lucy G. Vassar, limited details available electronic permit copy unavailable). [Additional Reference(s): DWR Levee Log, 2006. USACE Sacramento O&M Manual 108, April 1964, (HLM 3.12), Drawing No. 50-04-3379]. FS Date: 12/4/2013

Siphon breaker in steel riser on WS slope with pipe and flap gate visible in background at WS berm.

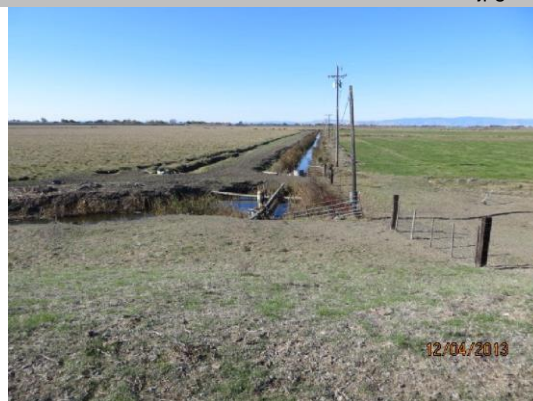
Photo 2 of 2 : UCIP_FA_2018_24990_45046.jpg

Pump on pier in ditch off LS toe.

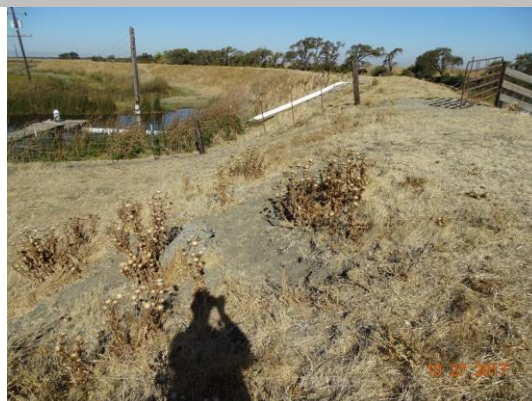
Photo 1 of 1 : FA_2018_RD2104_249_21_20180925_00008.jpg

LM Start	4.00	Rating **	M	Issue No.	21
LM End	4.00	Issue Type +	Ma	Location *	LS
Category	Earthen Levee			GPS Latitude/Longitude	
				Start	End
Item	Slope Stability			38.310672°	38.310672°
				-121.736155°	-121.736155°
DWR ID	DWR_RD2104_01_f_2018_21				
Comment Code					
S2 : Repair the levee slope damaged by foot traffic and prevent access where possible.					
Inspector Comment

Repair landside slope eroded by livestock, and prevent future erosion.

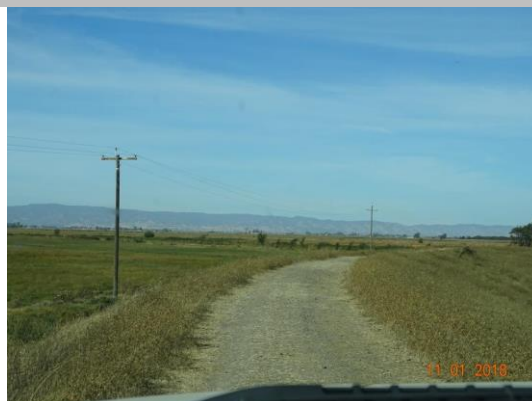
Photo 1 of 2 : FA_2018_RD2104_249_17_20181102_00037.jpg

LM Start	4.05	Rating **	M	Issue No.	17
LM End	4.30	Issue Type +	Ma	Location *	WS
Category	Earthen Levee			GPS Latitude/Longitude	
				Start	End
Item	Vegetation			38.311335 °	38.313822 °
				-121.736643 °	-121.739757 °
DWR ID	DWR_RD2104_01_s_2018_17				
Comment Code					
V2 : Remove the wild growth other than native grasses from the levee slopes.					
Inspector Comment					
Maintain vegetation on the water side slope

View looking upstream at vegetation on the water side slope (November 2018).

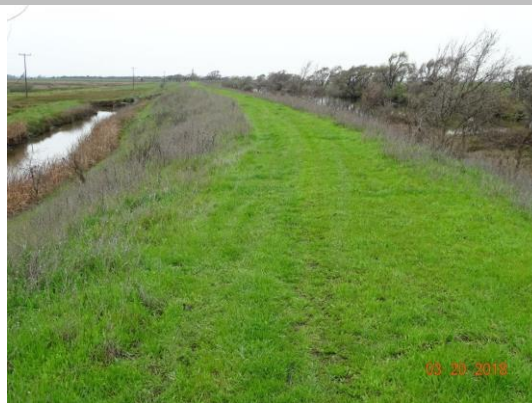
Photo 2 of 2 : FA_2018_RD2104_249_17_20180925_00006.jpg

Waterside (right) vegetation should be managed to 20 feet from crown to allow inspection and access.

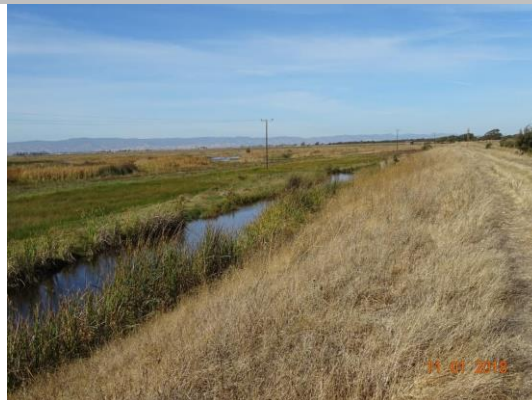
Photo 1 of 2 : FA_2018_RD2104_249_10_20181102_00038.jpg

LM Start	4.25	Rating **	M	Issue No.	10
LM End	4.30	Issue Type +	Ma	Location *	LS
Category	Earthen Levee			GPS Latitude/Longitude	
				Start	End
Item	Vegetation			38.313253 °	38.313822 °
				-121.739152 °	-121.739757 °
DWR ID	DWR_RD2104_01_s_2018_10				
Comment Code					
V2 : Remove the wild growth other than native grasses from the levee slopes.					
Inspector Comment					
Maintain vegetation on the land side slope

View looking upstream at vegetation on the land side slope (November 2018).

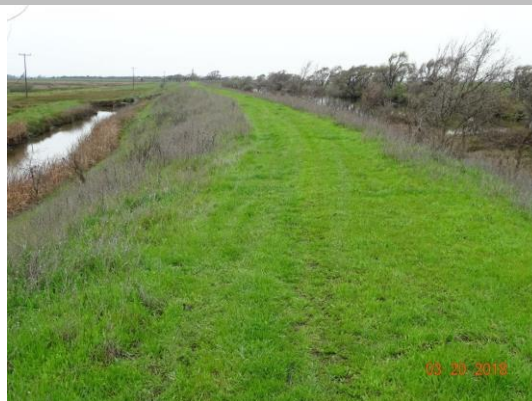
Photo 2 of 2 : FA_2018_RD2104_249_10_20180925_00001.jpg

Landside (left) vegetation should be managed to allow inspection and access to slope and toe.

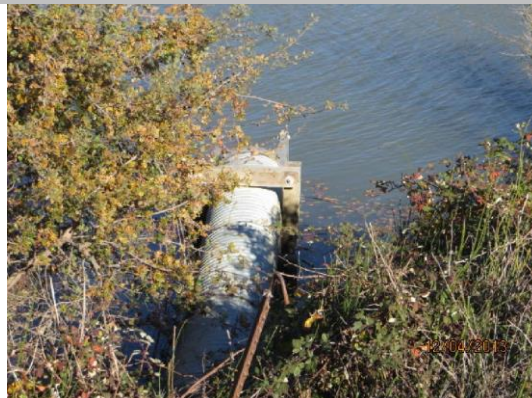
Photo 1 of 3 : UCIP_FA_2018_51459_45062.jpg

Comment Code					
Inspector Comment					
FS_ID:51459 DS_ID:24705 EP_NO: 10182 Repair Type: Non-Urgent Crossing Status: Found UCIP Comments: 12/06/2016 Crossing has been downgraded from "Urgent" to "Non-Urgent" no signs of leaks observed along pipe alignment (limited inspection on WS toe). According to LMA representative, this crossing was replaced 6 years ago (2010) at WS concrete apron. Recommend conducting internal inspection of pipe through the levee and LS to determine pipe integrity. (O. Magana - DWR UCIP)12/04/2013 Vegetation and soil buildup throughout pipe preventing flapgate from closing. Remove vegetation to allow gate to close properly. (W. Wylie - DWR UCIP) FIELD_STRUCT_DESC: 24-inch corrugated metal drainage pipe through the levee, 15 feet below the crown. 36-inch concrete standpipe on the landside (LS) toe. Flap gate on the waterside (WS) toe. Two corrugated metal cutoff walls installed. (24-inch pipe [HLM 4.65] authorized under Automatic Board Order (ABO) issued as Permit No. 10182, 1974 - Julia Trust Machado). [Additional Reference(s): DWR Levee Log, 2006. USACE Sacramento O&M Manual 108, April 1964, (HLM 4.65), Drawing No. 50-04-3379]. FS Date: 12/6/2016

CMP pipe and flapgate off WS toe.

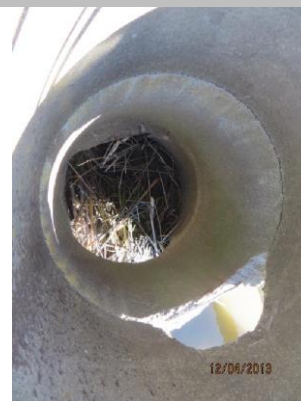
Photo 3 of 3 : UCIP_FA_2018_51459_45060.jpg

36-inch concrete riser with vegetation buildup inside.

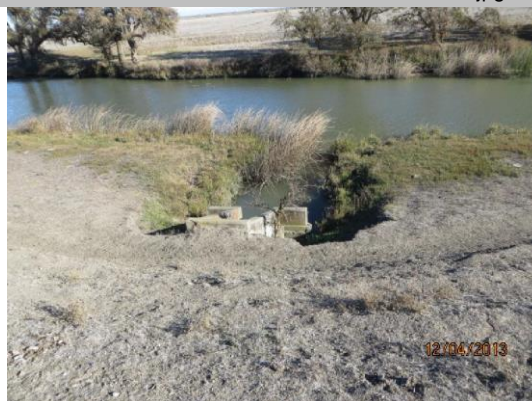
Photo 1 of 3 : UCIP_FA_2018_53387_45090.jpg

Item	DWR UCIP LMA Responsibility		38.322215°	38.322215°								
			-121.748418°	-121.748418°								
DWR ID	24701											
Comment Code												
Inspector Comment												
FS_ID:53387 DS_ID:24701 EP_NO: 10182 Repair Type: Urgent Crossing Status: Found UCIP Comments: 10/12/2018 Same as last inspection; concrete headwall on WS still being undermined so crossing remains Urgent (D. Sanoski - DWR UCIP). 12/06/2016 same as last inspection--pipe remains "Urgent" CMP shows holes through wall and concrete headwall is undermined. Need to contact owner. Owner will need to work with the CVFPB to comply with Title 23. (O. Magana - DWR UCIP) 12/04/2013 Footing under headwall on WS toe severely undermined. Pipe rusted heavily with holes at WS and may need replacement. (W. Wylie - DWR UCIP) FIELD_STRUCT_DESC: 24-inch corrugated metal drainage pipe through the levee, 13 feet below the crown. Two cutoff walls. Concrete U-shaped headwalls on both ends. Flap gate on the waterside (WS). (24-inch pipe [HLM 5.50] authorized under Automatic Board Order (ABO) issued as Permit No. 10182, 1974 - Julia Trust Machado). [Additional Reference(s): DWR Levee Log, 2006. USACE Sacramento O&M Manual 108, April 1964, (HLM 5.5), listed as a 12-inch pipe, Drawing No. 50-04-3379, listed as an 18-inch pipe]. FS Date: 10/12/2018 5:06:00 PM

Concrete U-shaped headwall on WS toe. Note erosion scarp around headwall.

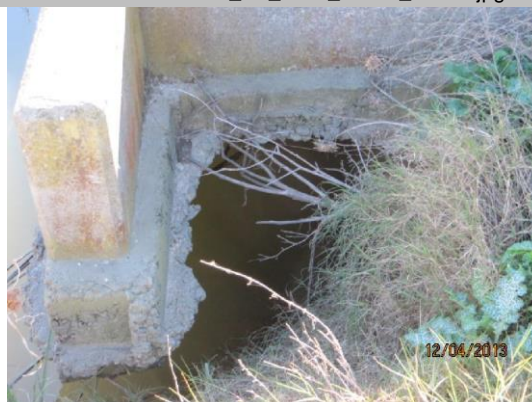
Photo 2 of 3 : UCIP_FA_2018_53387_45089.jpg

Headwall undermined on WS toe.

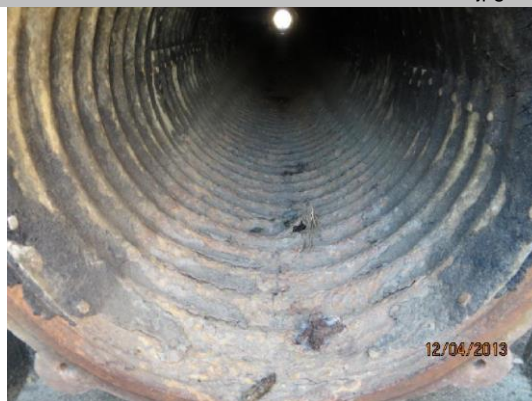
Photo 3 of 3 : UCIP_FA_2018_53387_45088.jpg

Comment Code						
Inspector Comment						
FS_ID:53387 DS_ID:24701 EP_NO: 10182 Repair Type: Urgent Crossing Status: Found UCIP Comments: 10/12/2018 Same as last inspection; concrete headwall on WS still being undermined so crossing remains Urgent (D. Sanoski - DWR UCIP).12/06/2016 same as last inspection--pipe remains "Urgent" CMP shows holes through wall and concrete headwall is undermined. Need to contact owner. Owner will need to work with the CVFPB to comply with Title 23. (O. Magana - DWR UCIP)12/04/2013 Footing under headwall on WS toe severely undermined. Pipe rusted heavily with holes at WS and may need replacement. (W. Wylie - DWR UCIP) FIELD_STRUCT_DESC: 24-inch corrugated metal drainage pipe through the levee, 13 feet below the crown. Two cutoff walls. Concrete U-shaped headwalls on both ends. Flap gate on the waterside (WS). (24-inch pipe [HLM 5.50] authorized under Automatic Board Order (ABO) issued as Permit No. 10182, 1974 - Julia Trust Machado). [Additional Reference(s): DWR Levee Log, 2006. USACE Sacramento O&M Manual 108, April 1964, (HLM 5.5), listed as a 12-inch pipe, Drawing No. 50-04-3379, listed as an 18-inch pipe]. FS Date: 10/12/2018 5:06:00 PM

Corosion through pipe with holes on WS toe.

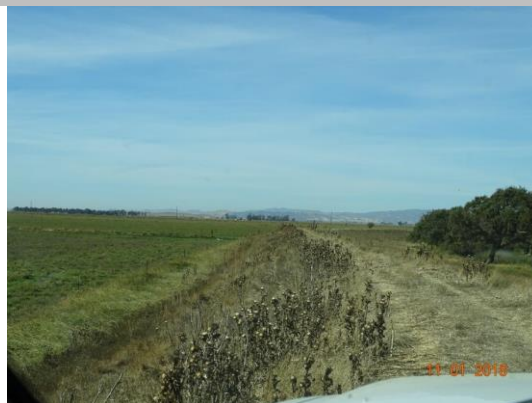
Photo 1 of 1 : FA_2018_RD2104_249_32_20181102_00040.jpg

LM Start	5.20	Rating **	M	Issue No.	32
LM End	5.28	Issue Type +	Ma	Location *	LS
Category	Earthen Levee			GPS Latitude/Longitude	
				Start	End
Item	Vegetation			38.323325 °	38.323277 °
				-121.749567 °	-121.751105 °
DWR ID	DWR_RD2104_01_f_2018_32				
Comment Code					
V2 : Remove the wild growth other than native grasses from the levee slopes.					
Inspector Comment					
Maintain vegetation on the land side slope

View looking upstream at vegetation on the land side slope (November 2018).
